## Additional Environment Protection of the AAA-1 and VDL-1 Devices

Chavdar Levkov, LZ1AQ [www.active-antenna.eu](http://www.active-antenna.eu)

Revision: 1.0 May. 29, 2014

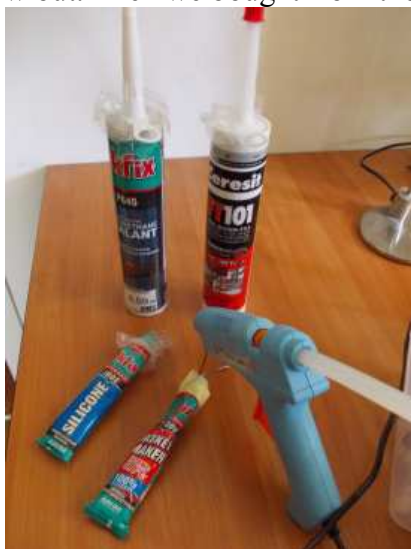
**Fig. 1**

Tested sealants: (A) Universal white silicone, type 100E from Akfix, (B) high temperature red silicone type 300H from Akfix, (C) polyurethane automotive sealant type P645 from Akfix, (D) special grey polymer sealant - type FT101 from Henkel, and (E) clear hot glue adhesive sticks – no name. We did not use strong adhesives which are available on the market since we wanted to keep the rubber junctions intact which will permit to change or repair the whole setup at later time. All these materials must be able to be removed in the case of maintenance.

The rubber caps must be sealed with proper stuff. We began with grease (technical Vaseline). It is better to nothing but does not cure the problem. Also in hot days it will become liquid and probably will flow out. Then we bought from the local store some sealing materials and tested them (**Fig.1**).

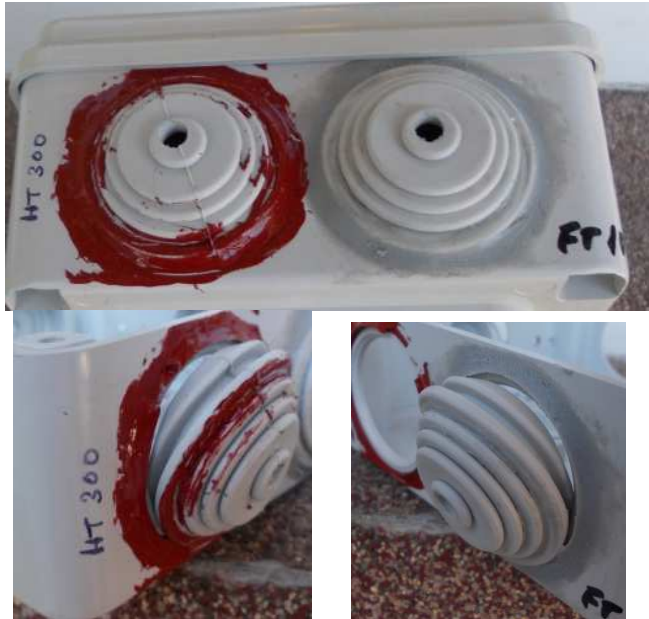
*Fig.2, 3, 4 High temperature red silicone B and grey polymer sealant D (sealed and un-mounted).*

We seal all caps with different sealants (*Fig. 2 to 12*) and tested them. The sealing was only on the surface. The results when we open the sealed caps are also shown. The adhesion is not strong and the sealants can be removed completely from the ABS box and rubber.

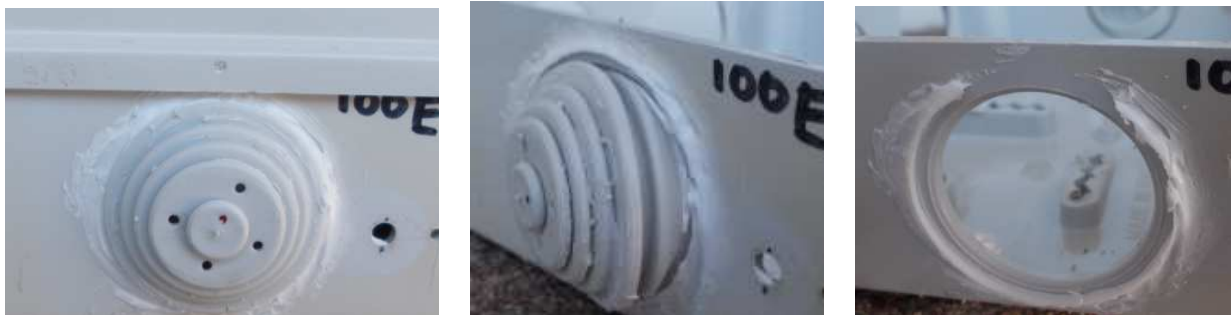
*Fig. 5, 6, 7 Universal white silicone A*

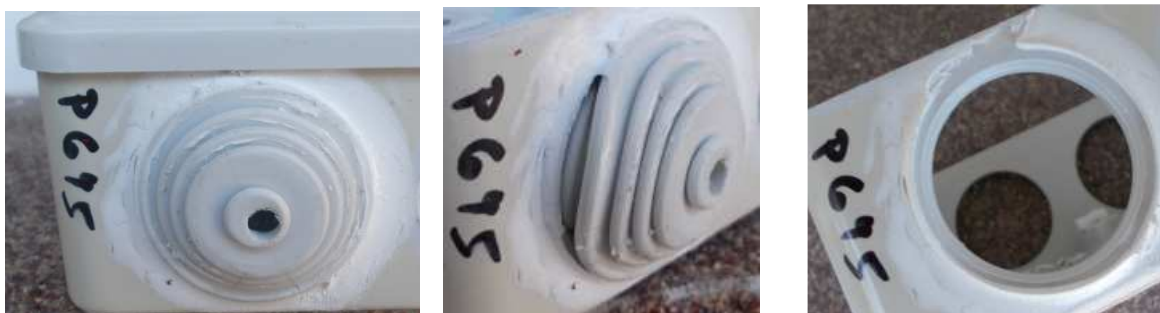
*Fig. 8, 9, 10 Polyurethane sealant C*

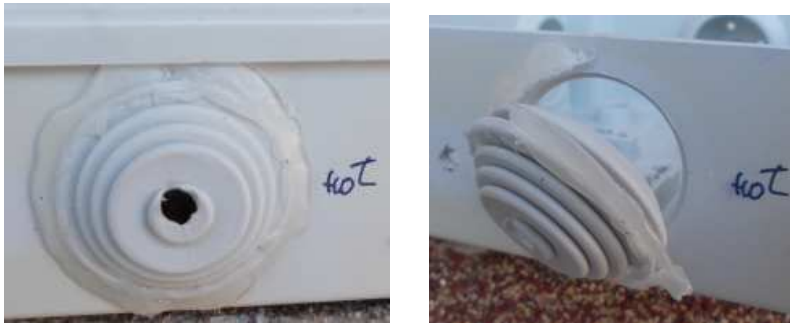
**Fig.11, 12** Hot glue clear type

After sealing the waterproof was 100%. Here is the ranking of different materials sorted to their adhesion to ABS and rubber.

Weak adhesion --> B-A-C-D-E --> strong.

The weakest adhesion has the red silicone B and the best was to hot glue E. The same seal can be used for the cable entrances (**Fig.17**)

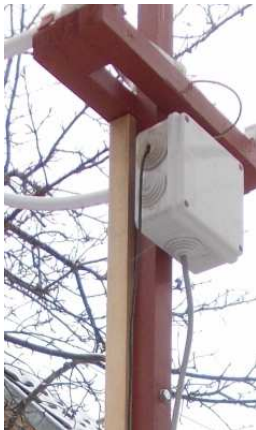
**Fig.13** The box is mounted vertically

Usually the amplifier is mounted vertically as shown on **Fig.13**. In this case we will suggest to do the following:

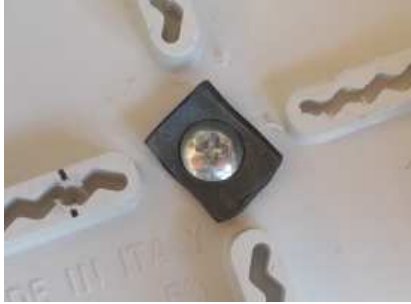
**Fig.14** Use rubber gasket for the screw that fix the box to the mast.

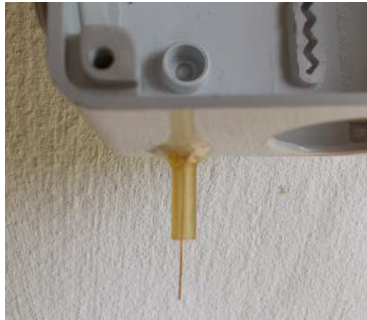
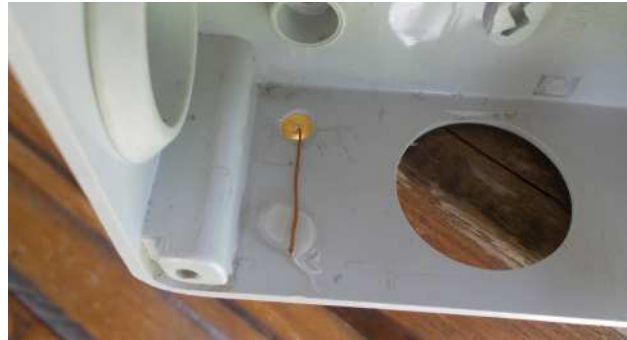
**Fig.15, 16** Drainage tube is placed at the bottom side of the box. A plastic tube with external diameter 5 mm and internal diameter is 3 mm is used for this purpose. A thin wire (0.4 mm diam.) is inserted into it to reduce the effects of the water surface tension. Thus it is possible to remove also the condensed water due to very fast changes of the temperature. The drainage tube and the wire are fixed with hot glue gun. The tube can be choked if not needed.

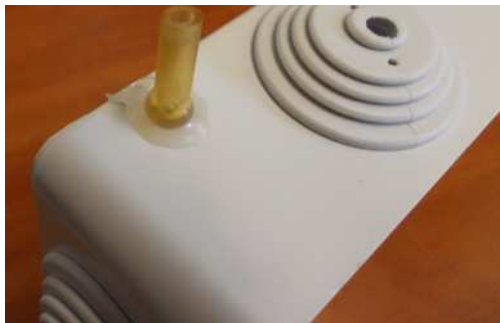
**Fig.16** There is no need to seal the lower cap where the FTP cable is passing through. One small hole can be punched into the rubber cap next to the cable hole for a water drainage.

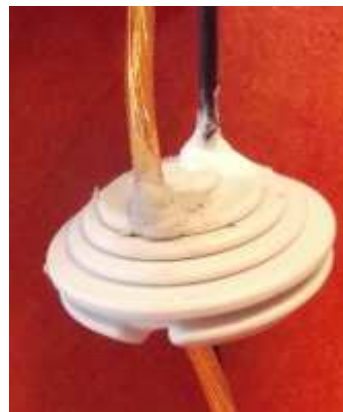
**Fig.17** A test example of the antenna terminals sealing. Polymer sealant D (grey) and universal silicone A are tested. Both are good for this purpose but the polymer adhesion is better.

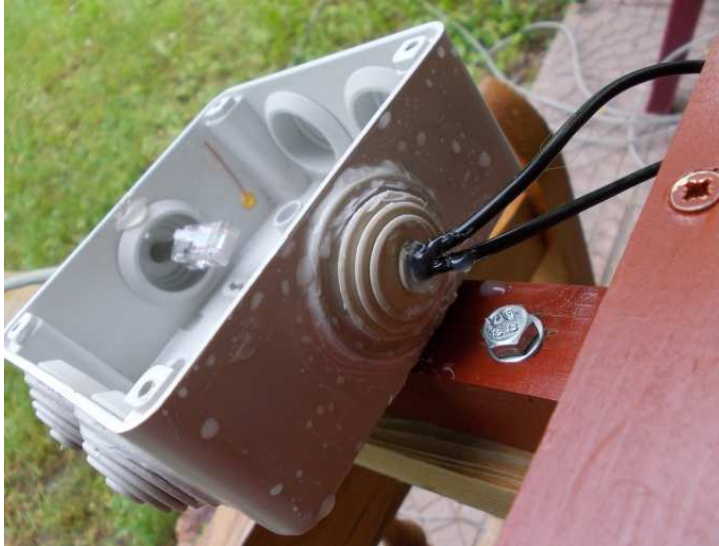
**Fig.18** Sealing of the antenna terminals and top cap. This box was inspected immediately after water shower test.

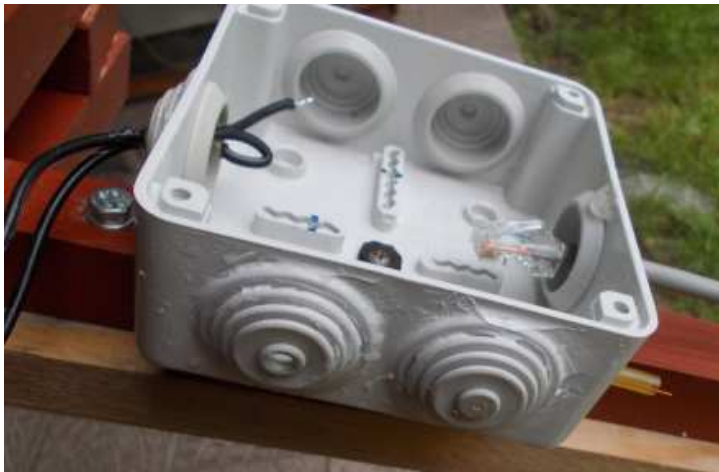
**Fig.19** Side caps are sealed with white universal silicone.

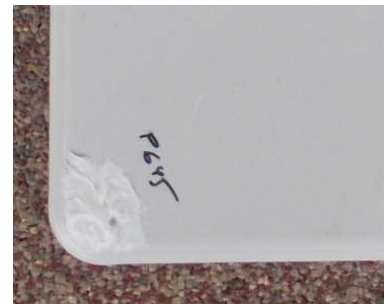
**Fig.20** The holes on the cover of the box can be sealed with the same sealants. Do not fill the hole but just make a surface layer. This layer will be removed easily when the box must be opened.

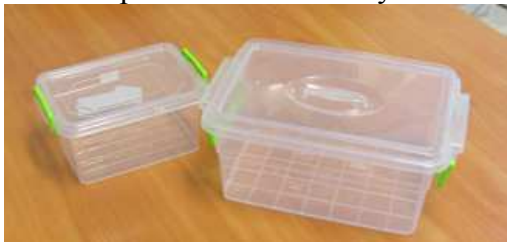
**Fig. 24** Polyethylene (PE) boxes for food.

This is the best way to protect the amplifier. There is no need for any sealing. There are boxes for food (**Fig. 24**) which are widely available on the market. The material is probably polyethylene (PE). These boxes can withstand temperatures from -25 to +80 deg (as written on the box bottom). The PE material is not very UV resistant. Probably black painting will help but the box is so cheap that it can be replaced after several years of sunlight exposure.

The price of such a box is 1-2 Euro. The box used in our example is approximately 140 x 190x 90 mm. Minimal efforts are needed to prepare the protecting box.

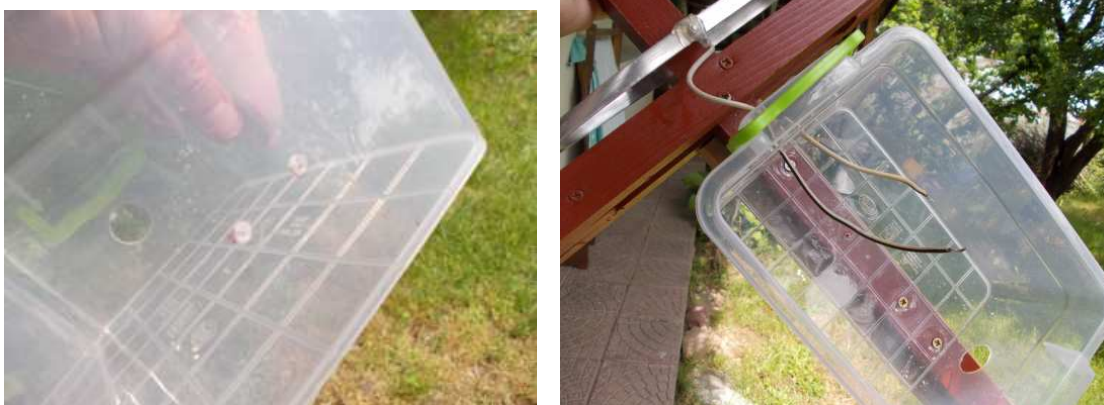
**Fig.25** Several holes must be drilled in the box – for antenna terminals with 0.9 of diameter of the antenna leads. The antenna leads must pass with difficulty through these holes. Also one hole with 20 mm diameter for the FTP cable. The RJ45 plug and the rubber cap must pass freely through the hole. Another two holes (5 mm diameter) must be drilled at the lowest part of the box for water drainage.

**Fig.26** The protection box is fixed to the mast with 3 screws.

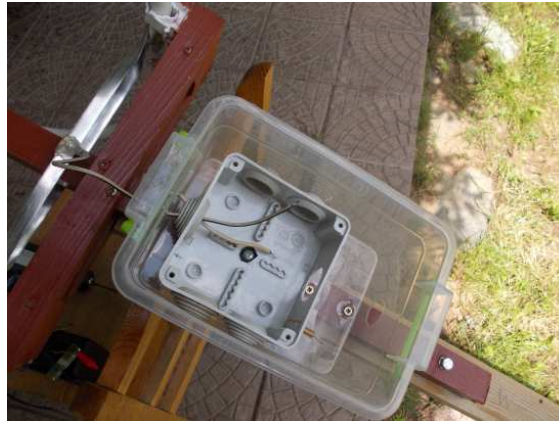
**Fig.28** The AAA-1 box is mounted into protection box. It is fixed with one screw at the center of the box with rubber gasket. There is a drainage tube in the ABS box for water condense drain.

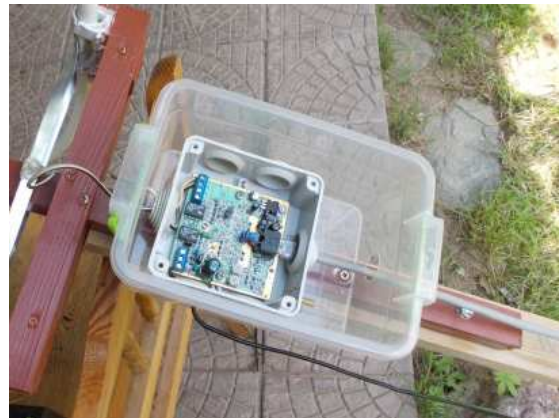
**Fig.30** FTP cable and lower dipole arm (the black wire) are mounted.

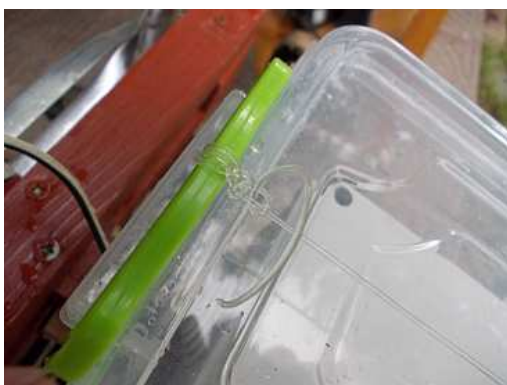
**Fig.31** The cover of the protection box is secured with nylon fishing cord.

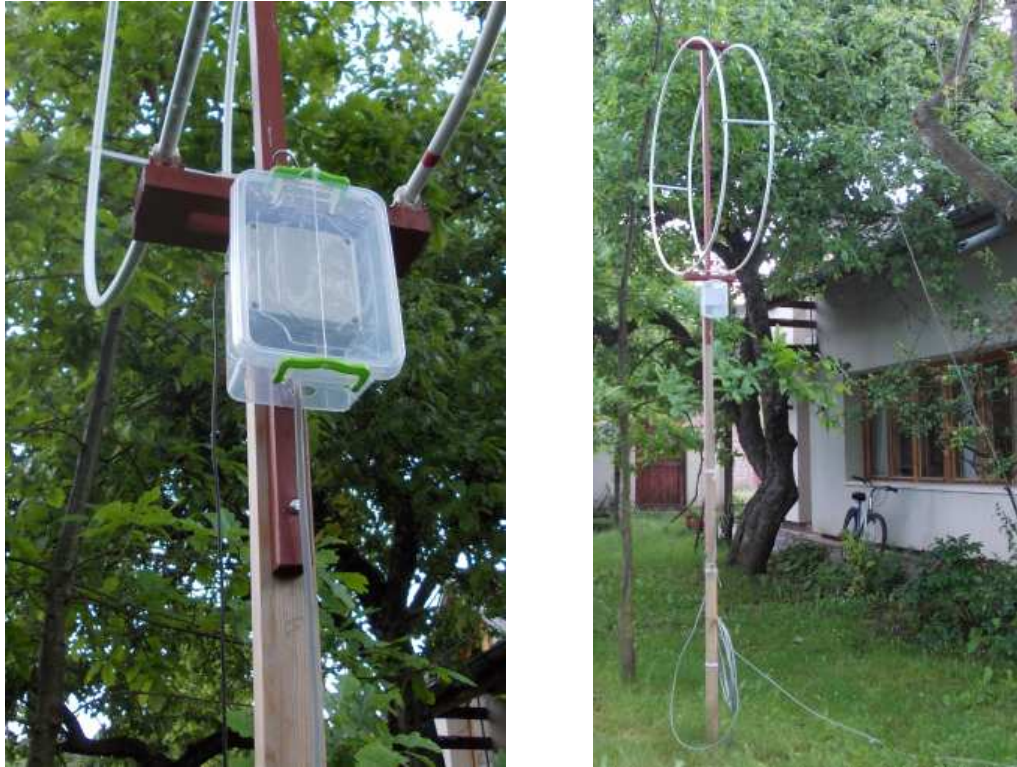
**Fig.32, 33** AAA-1 mounted with additional protection box. The amplifier is protected from any rain.

Protection with second external box has many additional advantages . For example it protects the rubber caps and the box from aging.

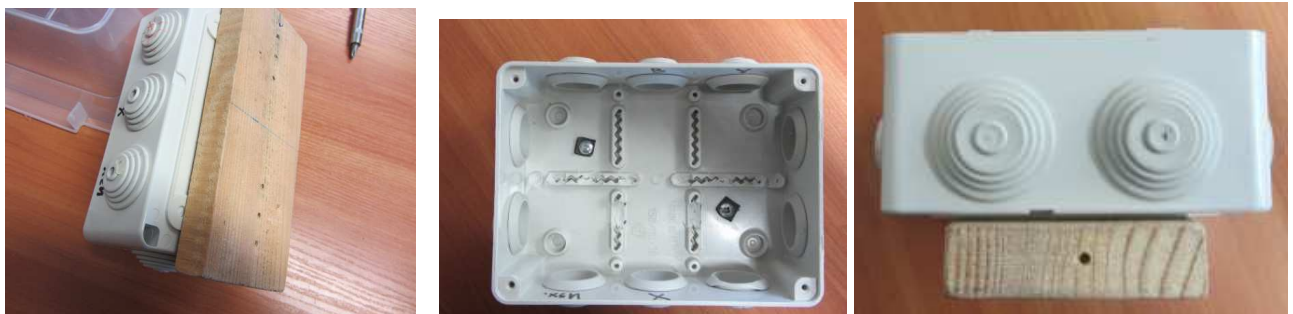
**Fig. 35, 36, 37** A wooden plank is prepared which length must be equal to the width of the protective box. A wooden plank is fixed to the VDLLine box with two screws.

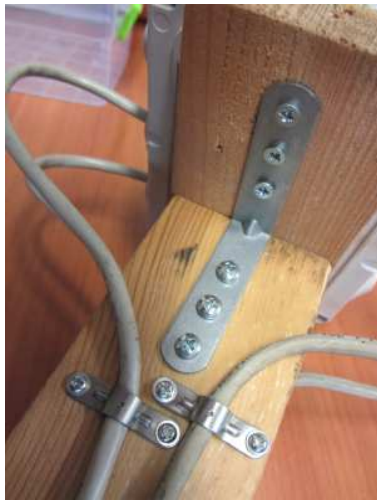
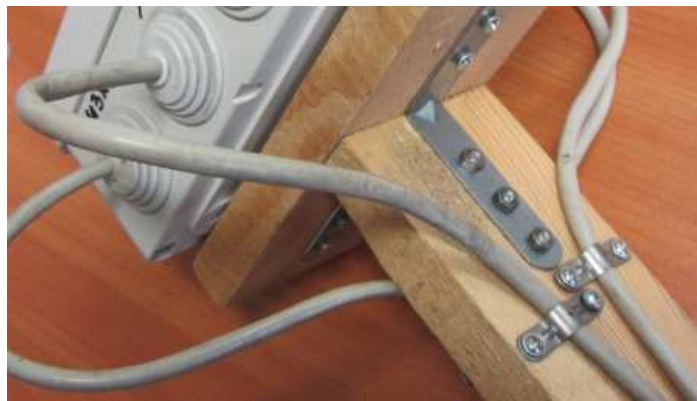
**Fig.39** The plank is fixed to the stake by means of two universal clamps. Another clamps are used to fix the FTP cables.

**Fig.40** Bolts with nuts are used to fix the stake in order to ease the mounting and un-mounting. At the beginning the stake must be inserted into the ground by means of hammer and then to mount the plank with the box.

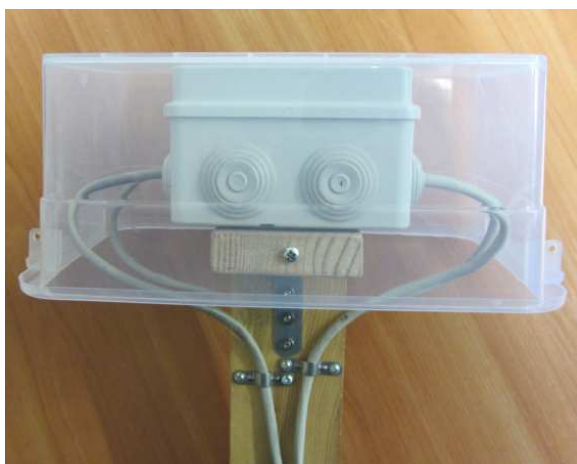
**Fig.41** The protection box is fixed upside down with 2 screws to the wooden plank. There is no need to close the box from the lower side. The handles are removed. The possibility for water to enter into the VDLline box is almost zero.

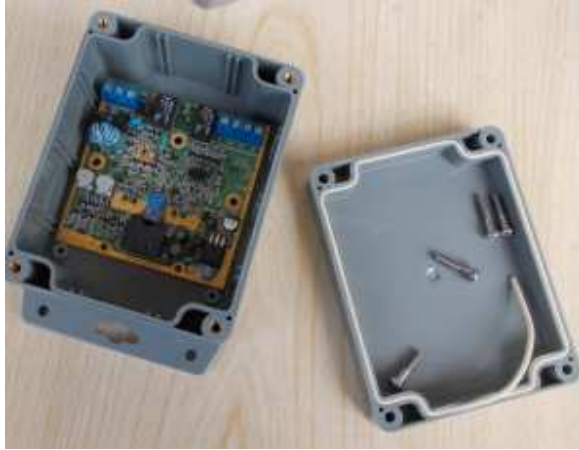
**Fig. 45 , 46**

On the market there are boxes with higher degree of protection e.g. IP65 or 66. ( the first figure is for dust protection and the second is for water protection). **Fig. 45, 46** . The main difference between them and the existing boxes are:

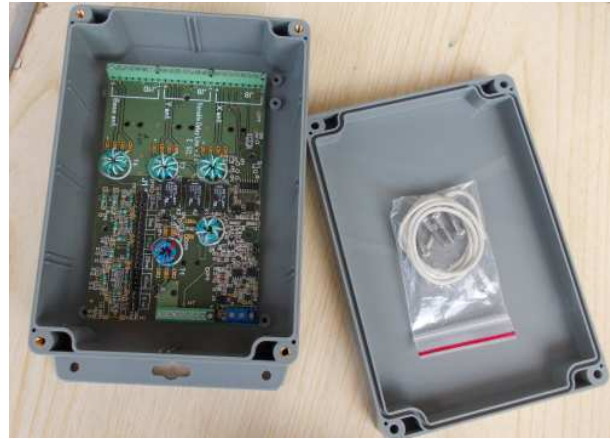
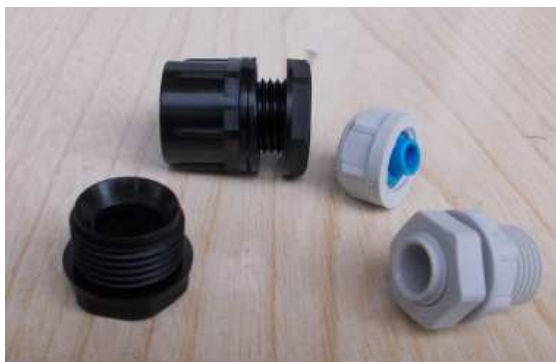
**Fig. 47, Fig.48**

- There are no rubber caps for the cable terminals. The cables must pass through the box wall with special cable glands (**Fig.47** )
- The bolts of the cover are screwed in metal nuts embedded into the box wall (**Fig.48**). This permits the cover to be fixed more tightly and thus to increase the insulation to dust and water. Also the walls of the box are more thick for the same reason.
- The bolts that fix the cover are outside the protected area (**Fig.48**) .

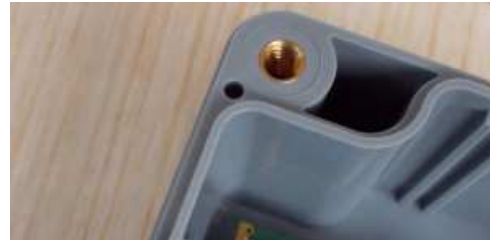
It is possible to mount AAA-1 or VDL-1 in such boxes but the user should again take measures for additional protection. These boxes are not 100 % waterproof also and there is always possibility for water condense to appear due to sudden thermal difference between external and internal sides. For AAA-1 board the problem is also the insertion of the RJ45 plug which must be inside the protected area of the box.
